Certification Tests on Cold Patch Asphalt Repair Materials for Use in Airfield Pavements

June 2010

Final report

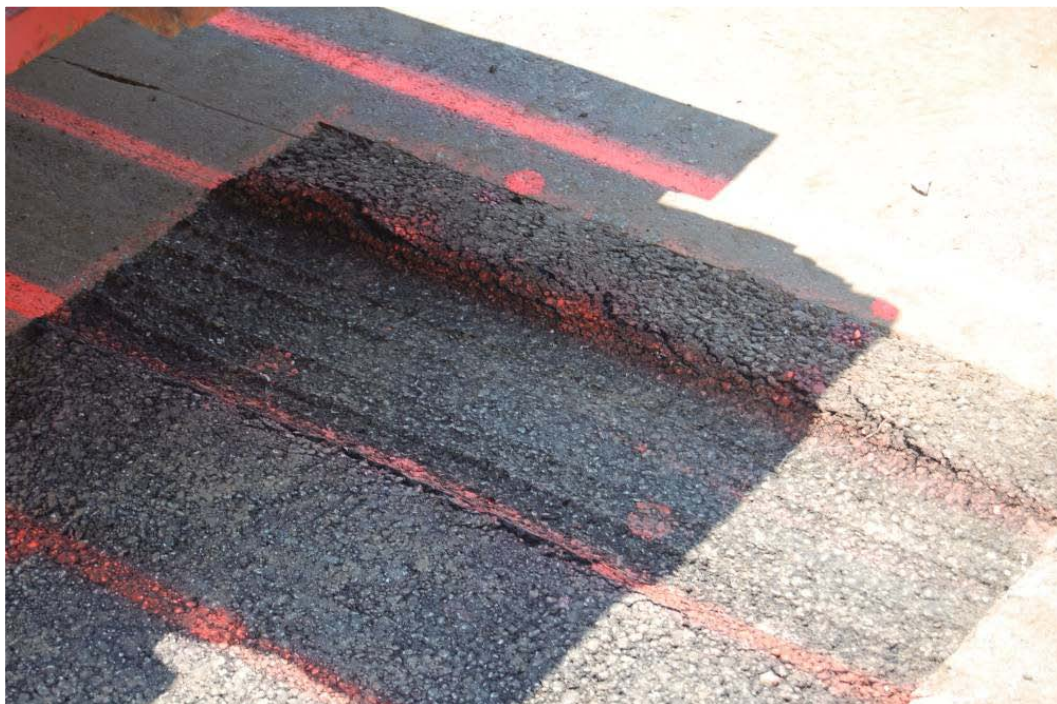
Figure 30. Deformation after the third pass over Instant Road Repair.

After the first three passes, each of the repairs exhibited large deformations causing significant rutting along the first traffic lanes (Figure 30). This rutting continued in all lanes during the test and, because of excessive deformations, only one pattern of 16 passes was completed for each repair. The products failed due to two conditions: a rut depth greater than 1 in. and a significant amount of loose material. The bonding between the binder and the aggregates was not strong enough to hold the aggregate in place during traffic loading. For airfield use, loose material represents high FOD potential and was therefore considered as a failure mode. The product for which the lowest amount of loose material was observed was Instant Road Repair.

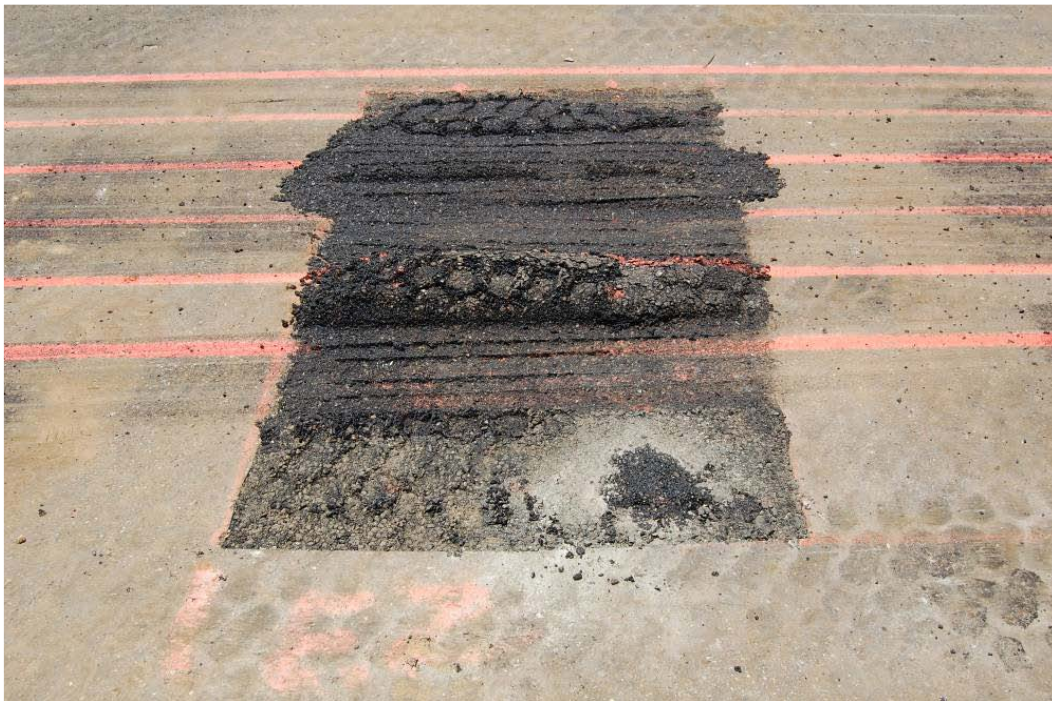
Figure 31. Failure in repair 1 EZ-Street.

In the case of EZ-Street Hybrid, the significant amount of loose material was also identified as a failure mode. It was considered that this amount of loose material would be significant enough to prevent any aircraft operation on an airfield due to the FOD potential that it could represent. The repair failures are shown in Figure 31–Figure 35.

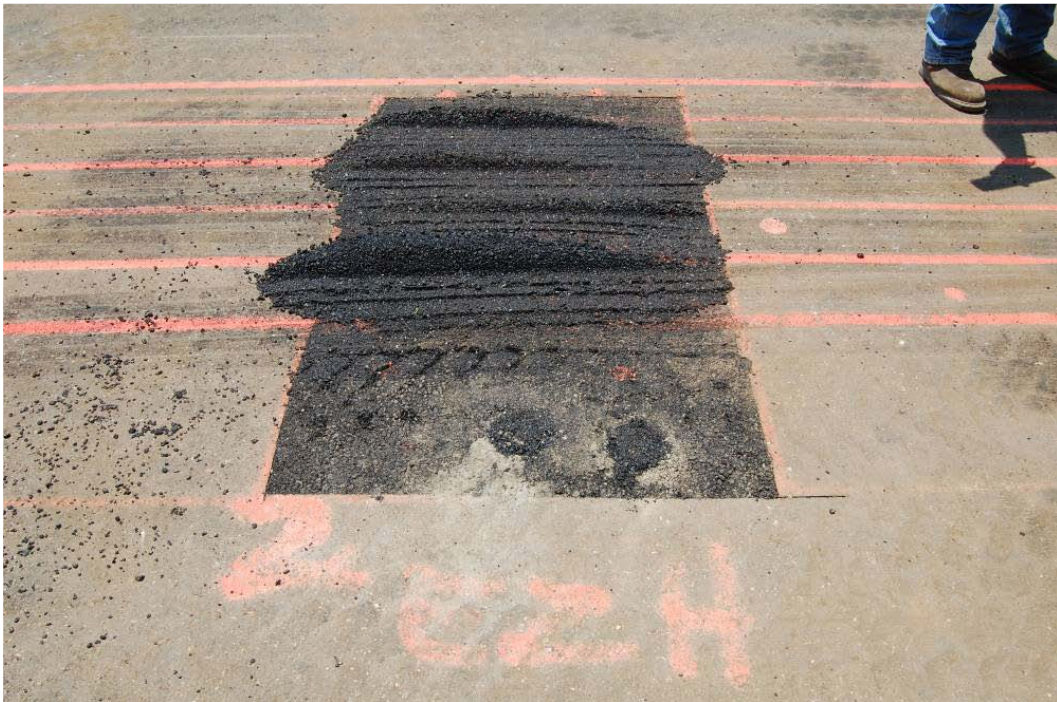
Figure 32. Failure in repair 2 EZ-Street Hybrid.

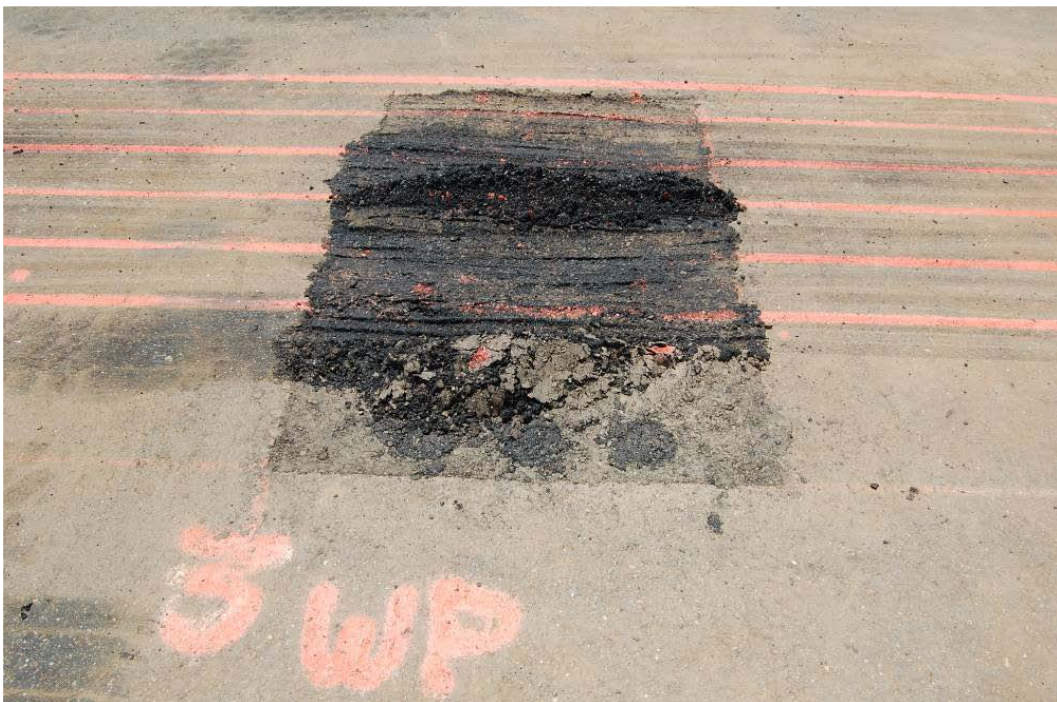
Figure 33. Failure in repair 3 Wespro.

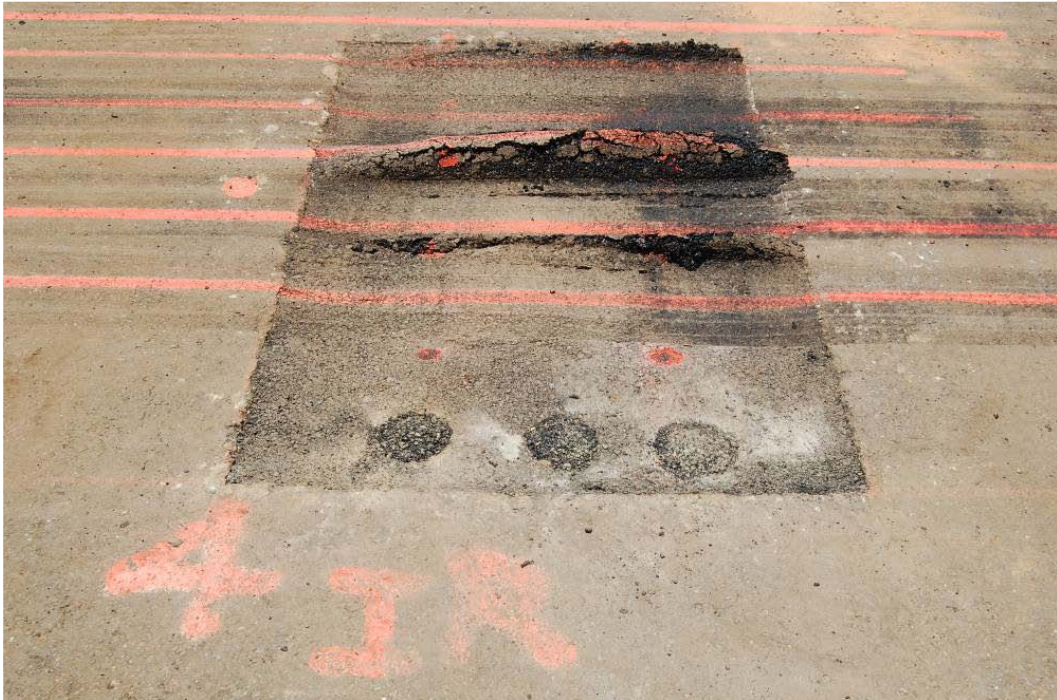
Figure 34. Failure in repair 4 Instant Road Repair.

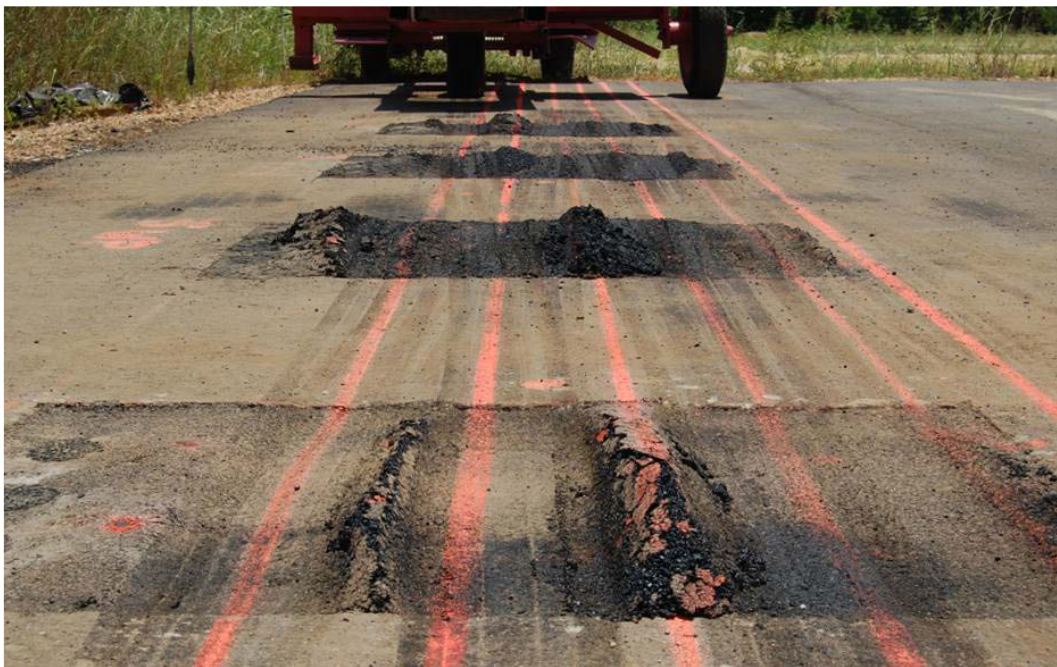
Figure 35. Overall photo of the repairs after 16 passes.

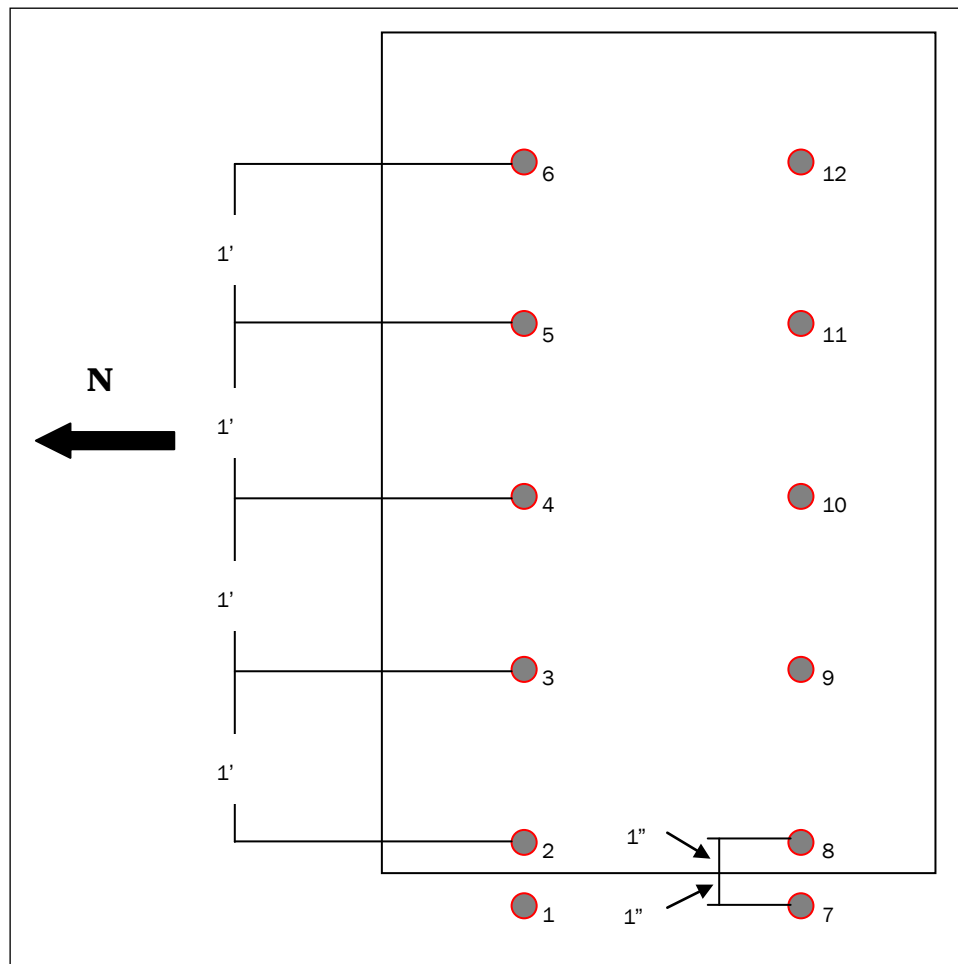
Figure B1. Distribution of the points for level measurements.

Figure B1 shows the points where measurements were taken. Figures B2–B9 show the cross sections that were measured before and after traffic.

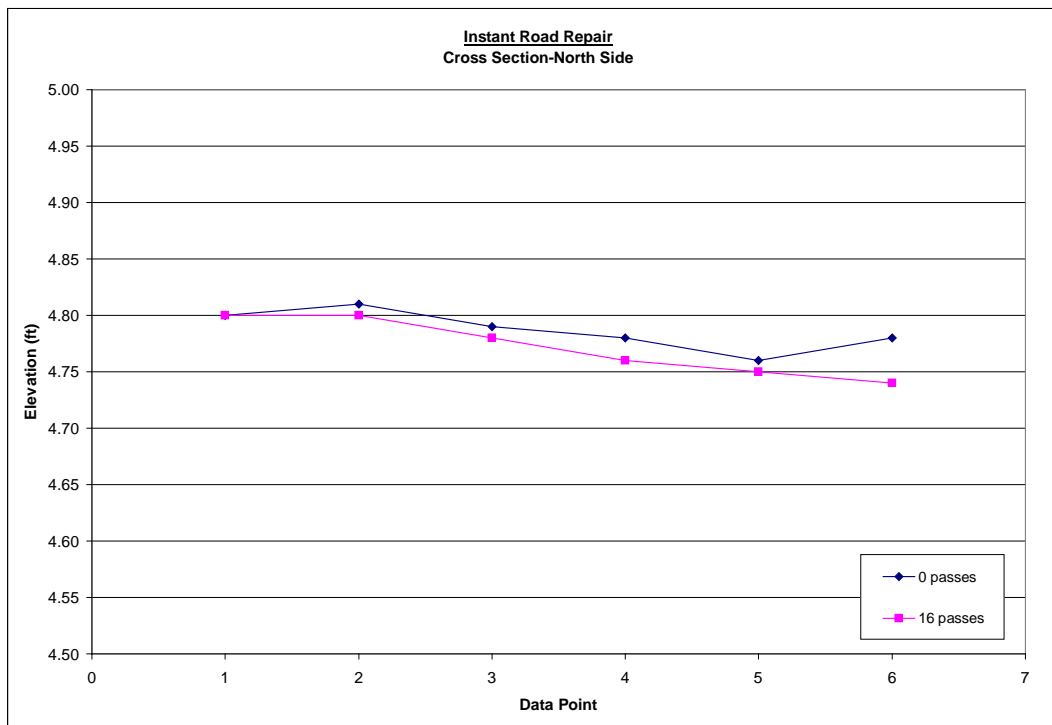
Figure B2. North cross section of the IRR repair area before and after traffic.

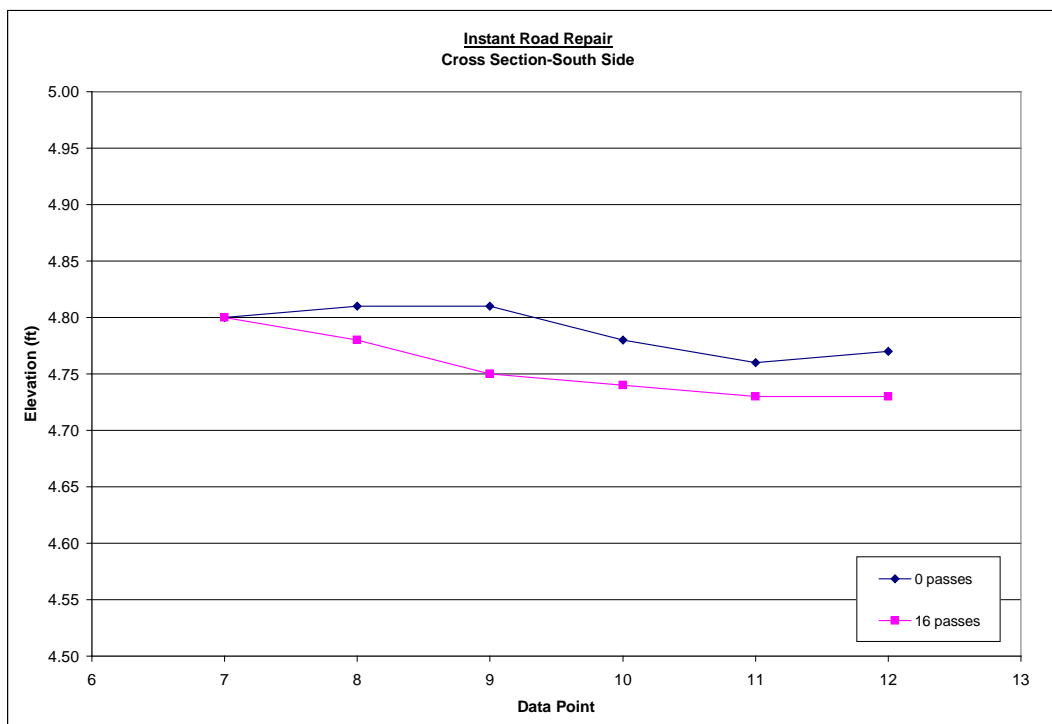
Figure B3. South cross section of the IRR repair area before and after traffic.

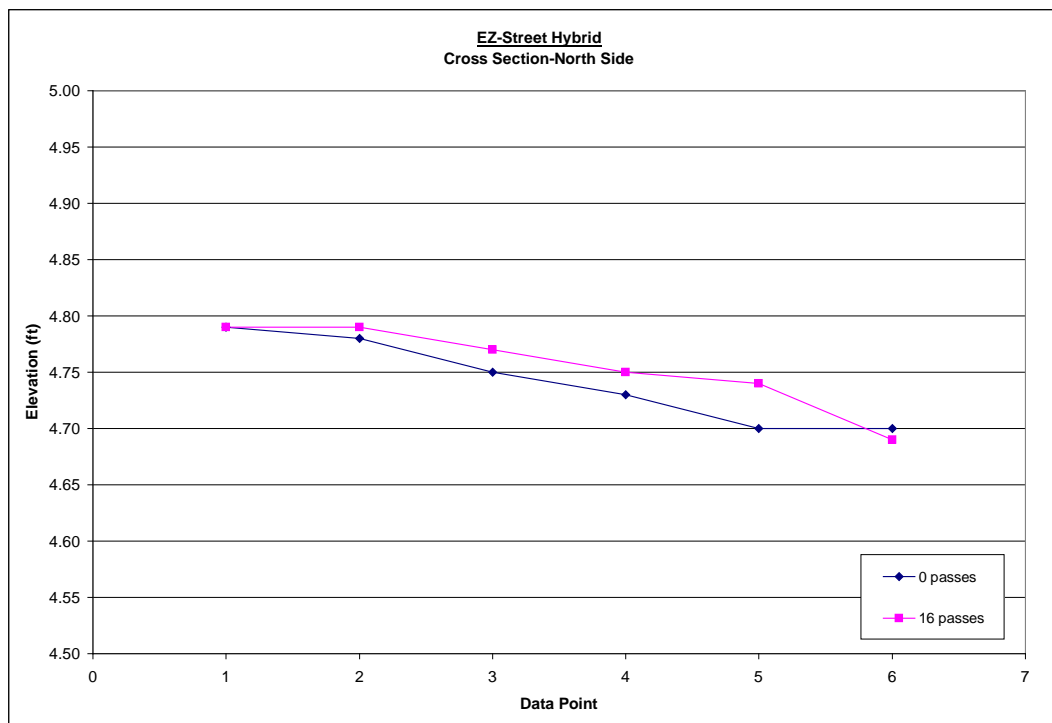
Figure B4. North cross section of the EZ-Street Hybrid repair area before and after traffic.

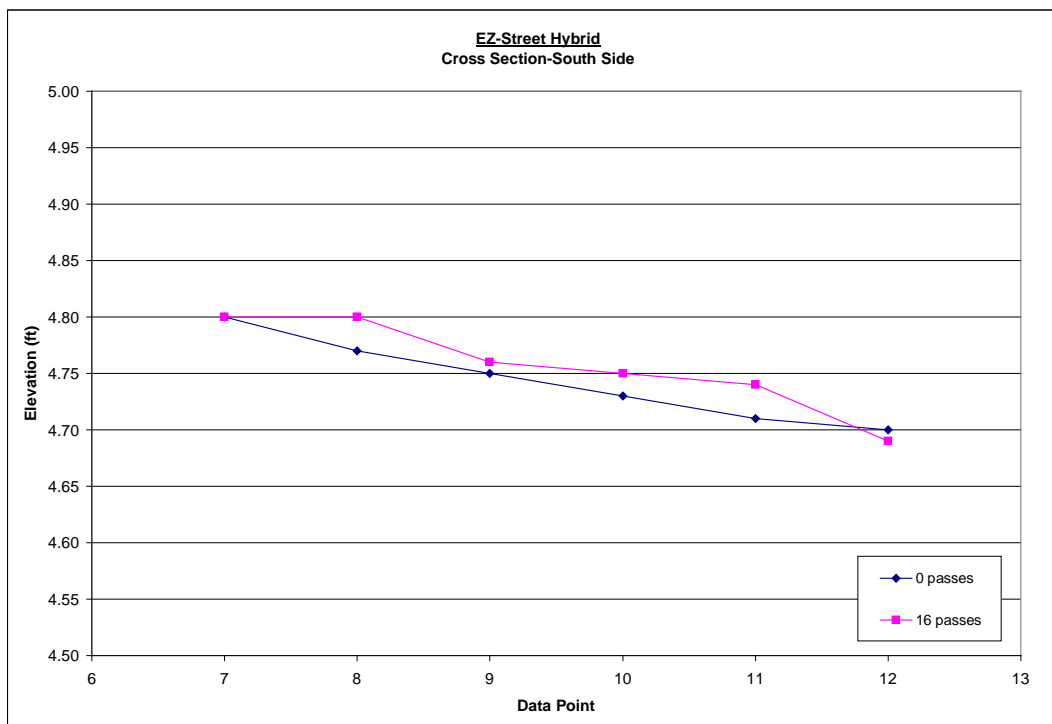
Figure B5. South cross section of the EZ-Street Hybrid repair area before and after traffic.

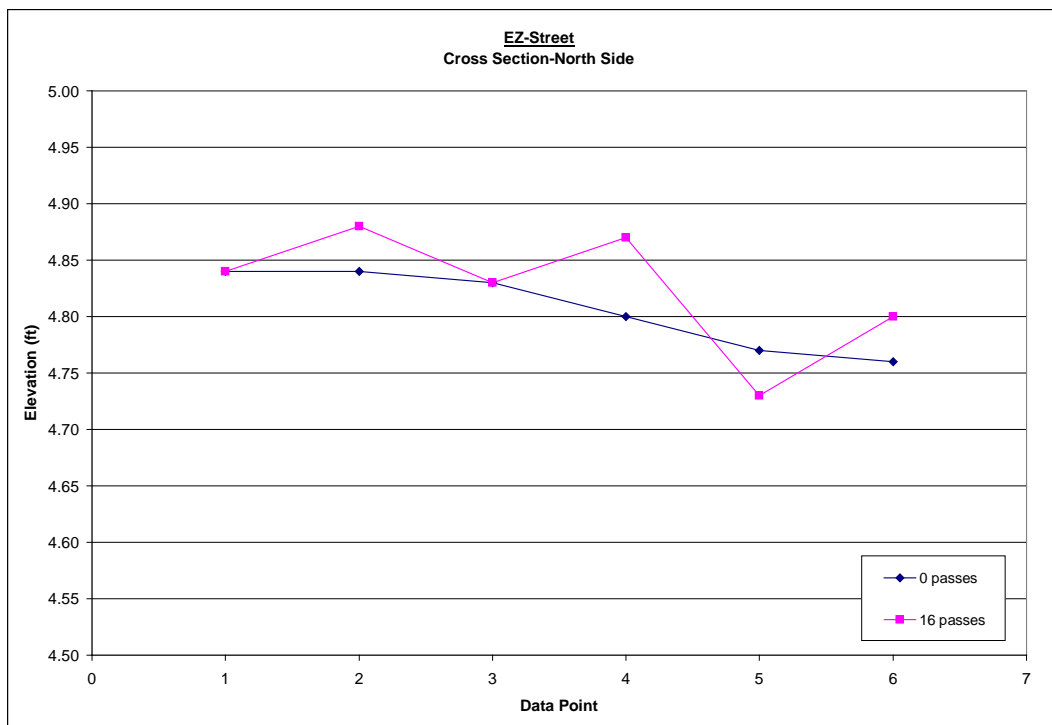
Figure B6. North cross section of the EZ-Street repair area before and after traffic.

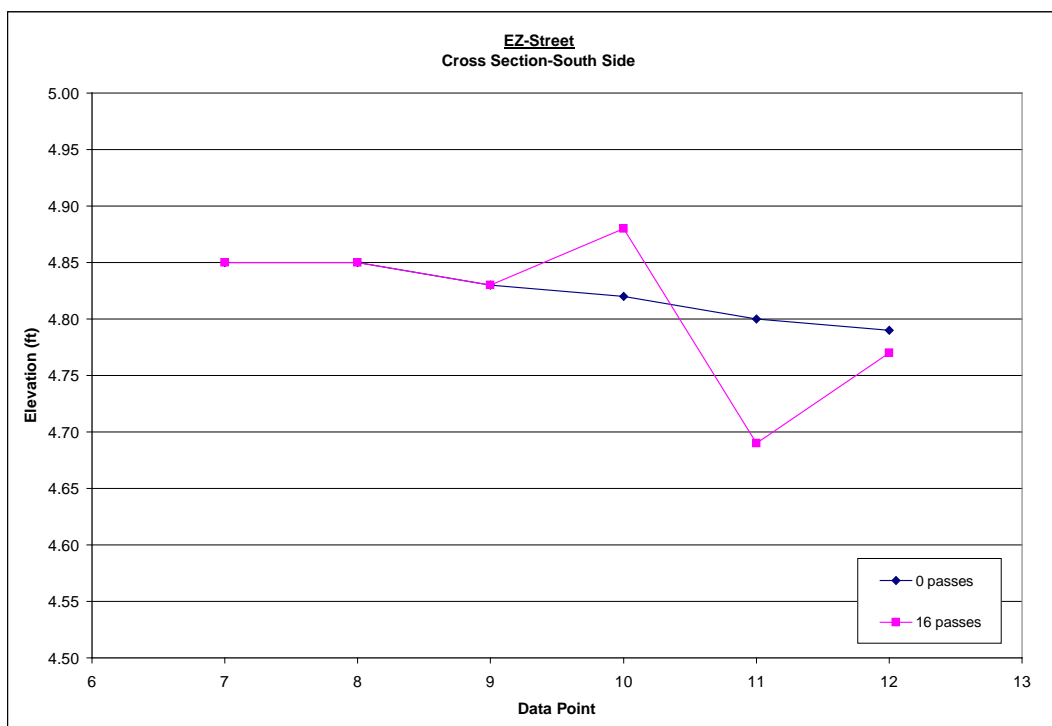
Figure B7. South cross section of the EZ-Street repair area before and after traffic.

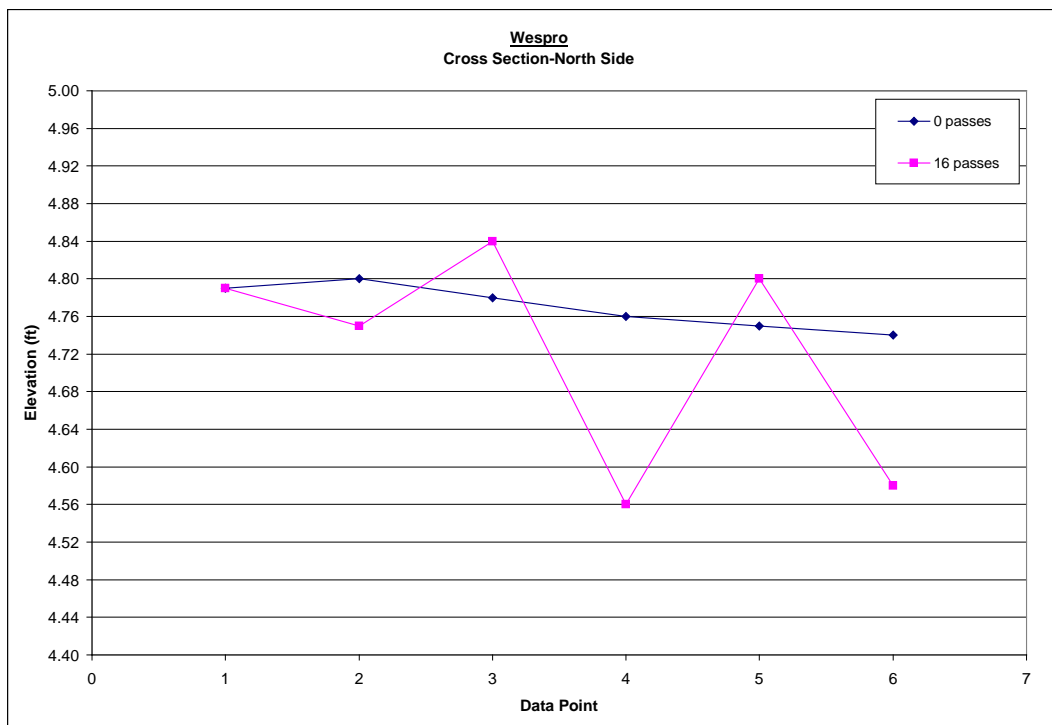
Figure B8. North cross section of the Wespro repair area before and after traffic.

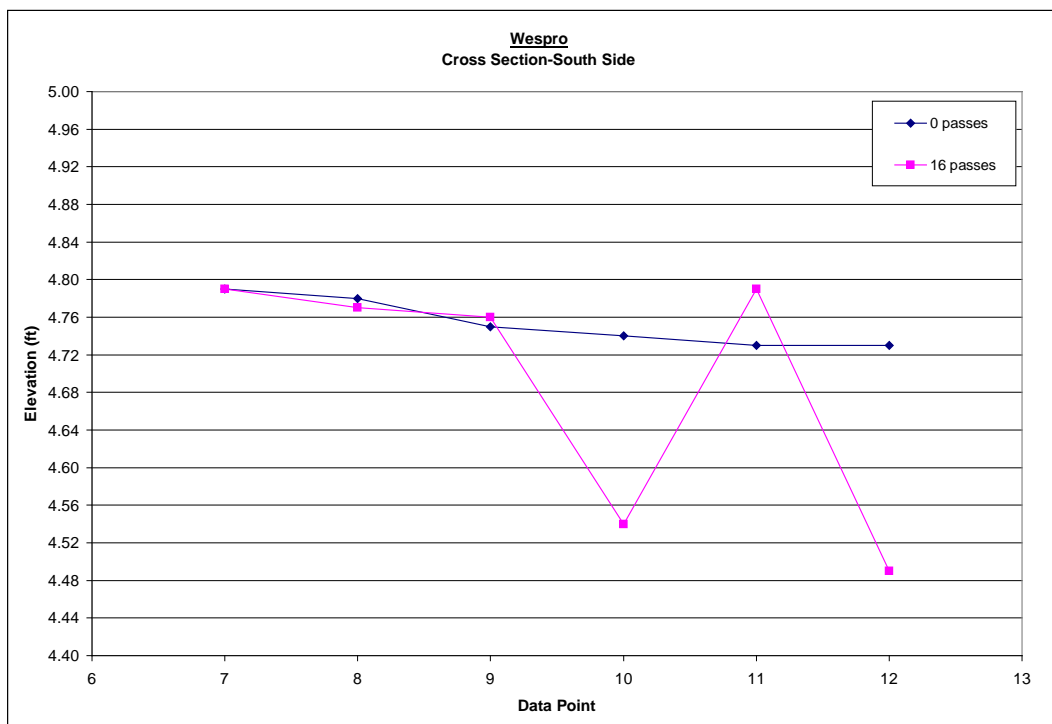
Figure B9. South cross section of the Wespro repair area before and after traffic.
